# Manhole Inspection Summary

Manhole # S250\_\_016MH

Insp Date: **4/2/08 10:28 AM**

**Location** Address: **1307 S. Washington**

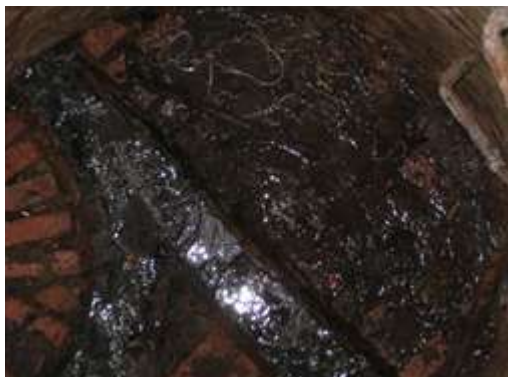
Defect 3

Condition: ☐ Sound ☐ Cracked ☐ Root Intrusion ☐ Deteriorated ☐ Leaks ☒ **Debris**

Bench and Channel Debris

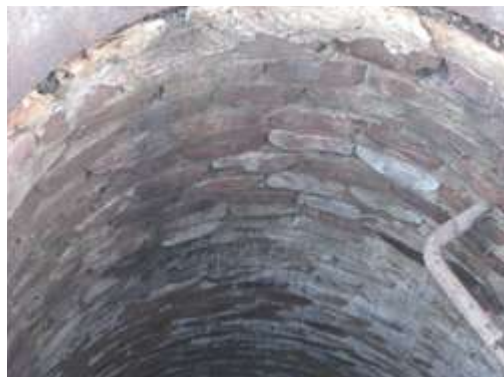
Defect 2

Condition: ☐ Sound ☐ Cracked ☐ Root Intrusion ☐ Loose Brick ☒ **Deteriorated**

Infiltration: ☐ None ☐ Joint ☐ Cracks ☐ Mortar ☐ Roots ☒ **Wall**

signs of infiltration from underneath frame, chimney and corbel infiltration

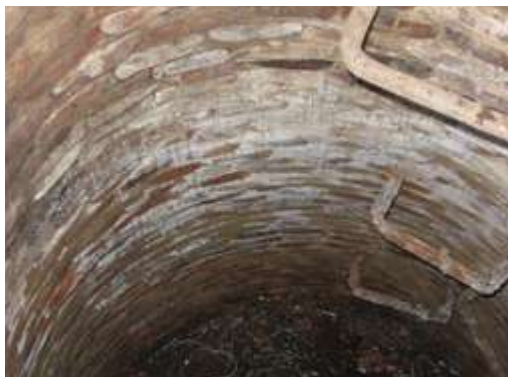
Defect 4

Infiltration: ☐ None ☐ Joint ☐ Cracks ☐ Mortar ☐ Roots ☒ **Wall**

Infiltration along barrel walls

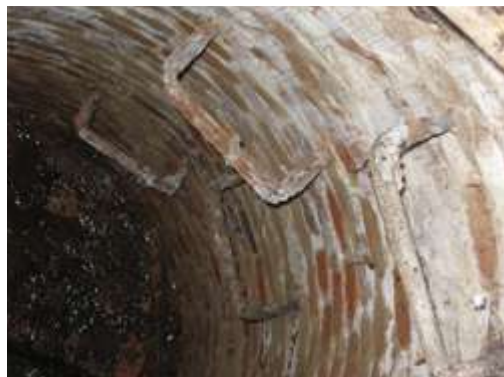
Defect 1

**Steps** Count: **5** Missing: **0** ☒ **Corroded**

Corroded steps

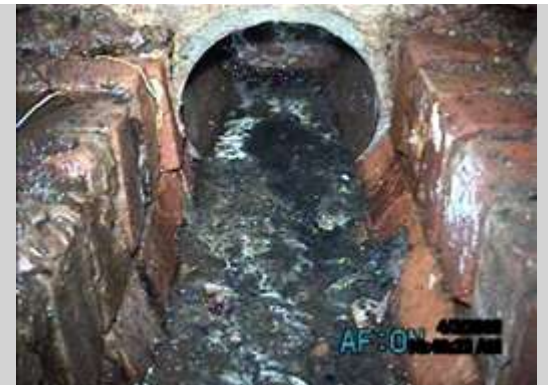
6 O'Clock Inflow

heavy deposits in channel

Pipe Height: **8.4** (in.) Rod and Bar (Angled)  
Pipe Material: **Clay** ☐ Pipe Lined  
Invert Depth: **10.19** (ft.) Flow Characteristics: **Slow**  
Deposits: ☐ None ☐ Mud ☒ ~~Gravy~~ ☒ Debris ☐ Grease  
Silt Depth: **3** (in.) Deposits Extent: **Medium**  
Infiltration: **None** Pipe Seal Cond: **Sound**

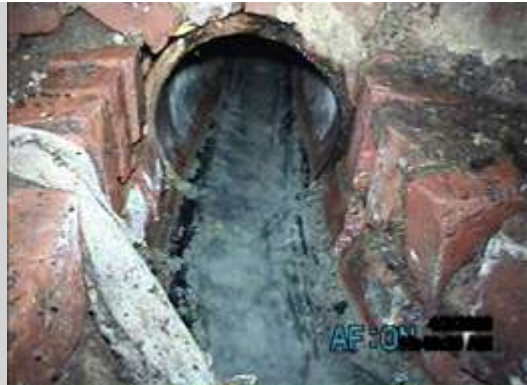
9 O'Clock Inflow

Deposits: ☐ None ☐ Mud ☒ **Sludge** ☐ Debris ☐ Grease

Silt Depth: **0.5** (in.) Deposits Extent: **Light**
